FR-21538  
October 1992

# FIBER COATING BY SPUTTERING FOR HIGH TEMPERATURE COMPOSITES

## FINAL TECHNICAL REPORT

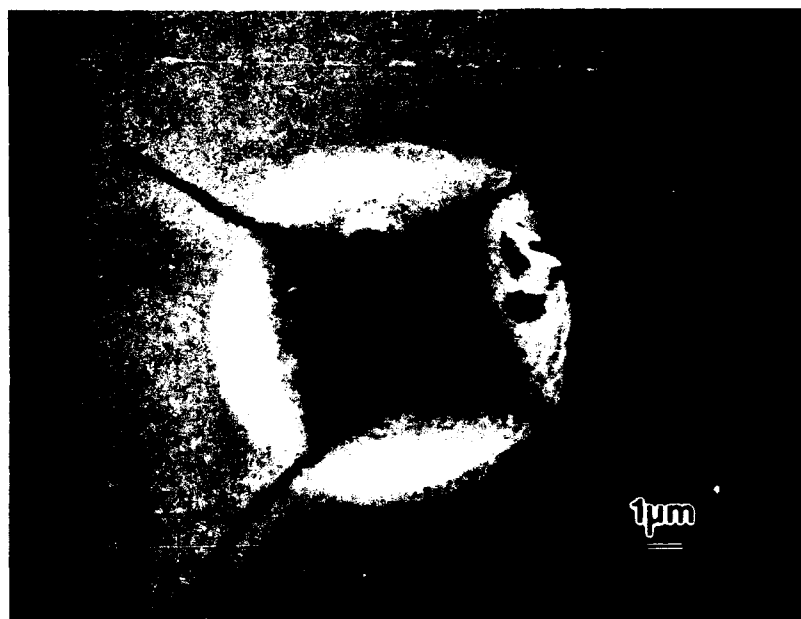
Figure 16b. Backscattered SEM micrograph of a Vickers indentation in  $\text{Y}_2\text{O}_3$  coating at 0.49 N load. Note the radial cracks at the corners of the indentation.

Vickers indentation tests of gold-coated  $Y_2O_3$  did not produce radial cracks at loads less than 0.391 N, while loads >0.538 N caused coating spallation which prevented measurement of radial cracks. Figure 16b shows radial cracks introduced in  $Y_2O_3$  by Vickers indentation at 0.49 N load. Five indentations were made at various loads to obtain average values of radial crack length. The indenter load is plotted versus the radial crack length according to the relation [26]:

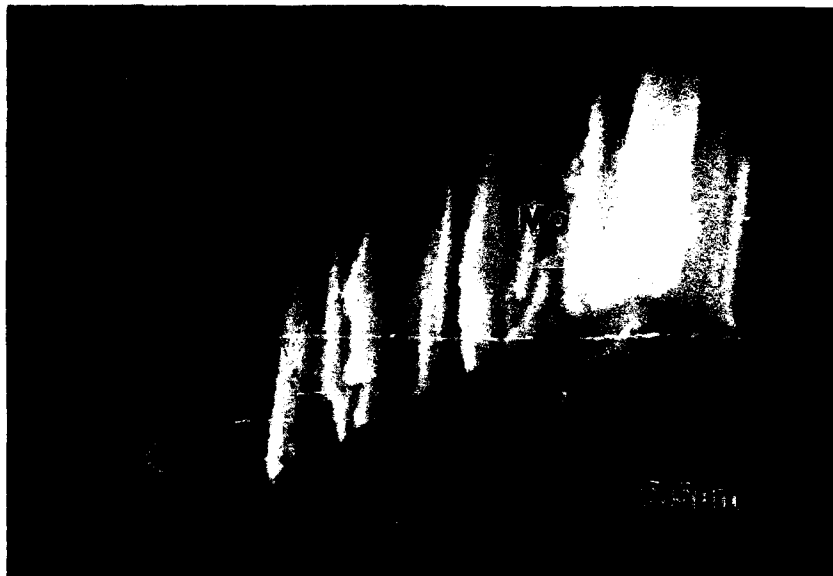
Figure 5. Secondary electron image of fracture surface showing the sol-gel Al<sub>2</sub>O<sub>3</sub> and Mo coatings.

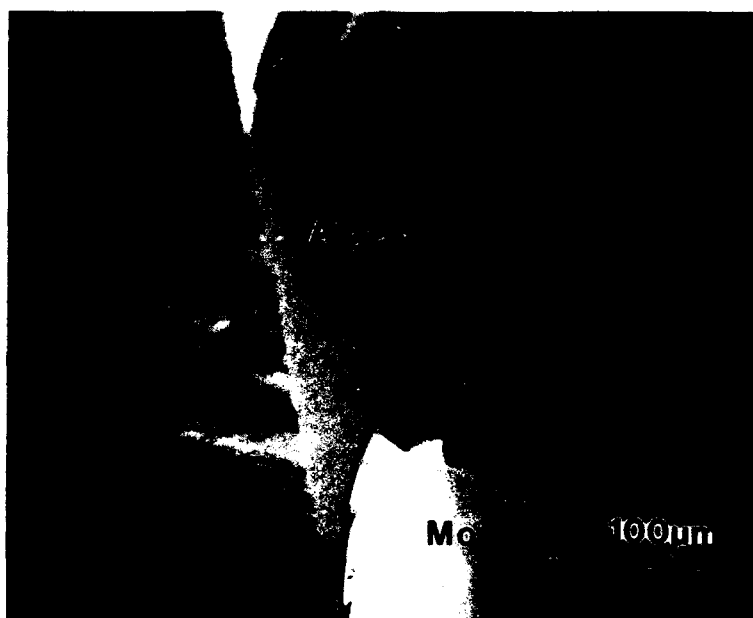
**Figure 6.** Sol-gel  $\text{Al}_2\text{O}_3/\text{Mo}$  dual layer coating on sapphire monofilament. Specimen mounted for composition depth profile by Auger electron spectroscopy. The outer layer of sol-gel  $\text{Al}_2\text{O}_3$  has spalled off.

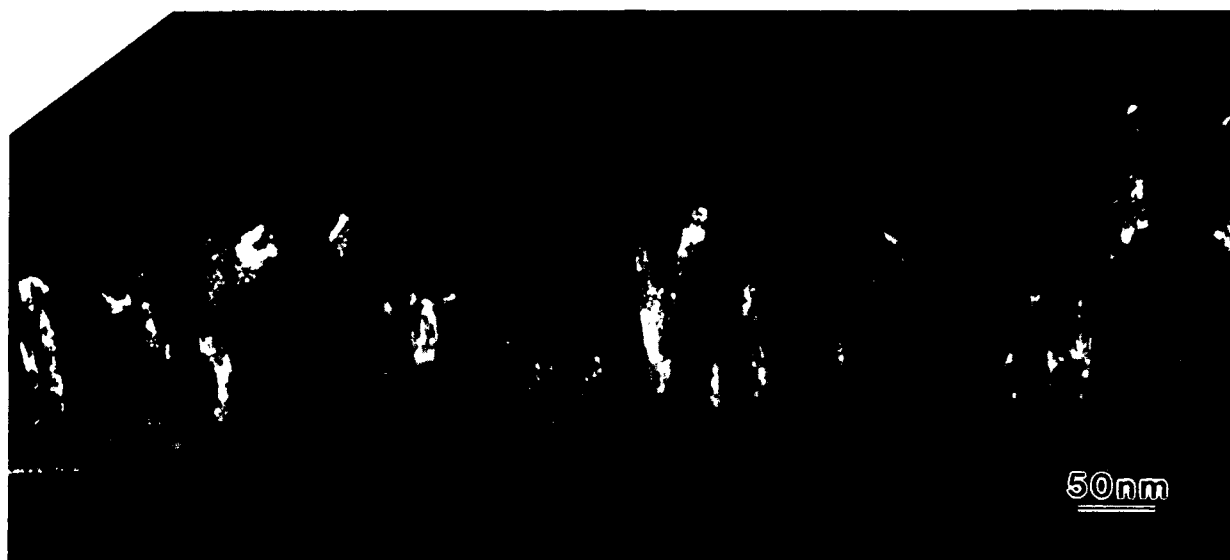
Figure 11. Dark field TEM image and associated SADP for the molybdenum coating. Image formed by combined  $0006\text{Al}_2\text{O}_3$  and  $110\text{Mo}$  diffracted intensity. The specimen is tilted so that the beam direction is near  $[\bar{2}110]\text{Al}_2\text{O}_3$ .

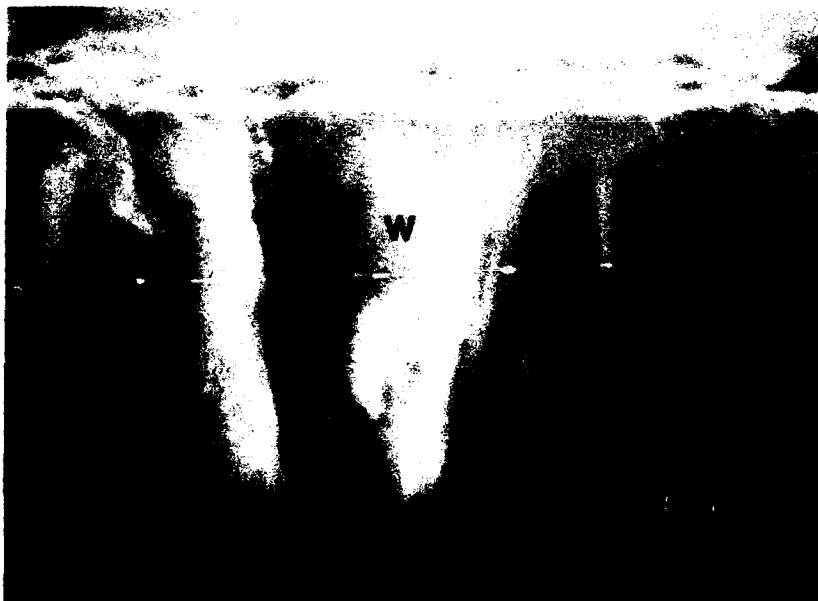
Figure 16. High resolution SEM images of the tungsten fracture surface. The sol-gel  $\text{Al}_2\text{O}_3$  coating has delaminated and is not present in this photomicrograph.

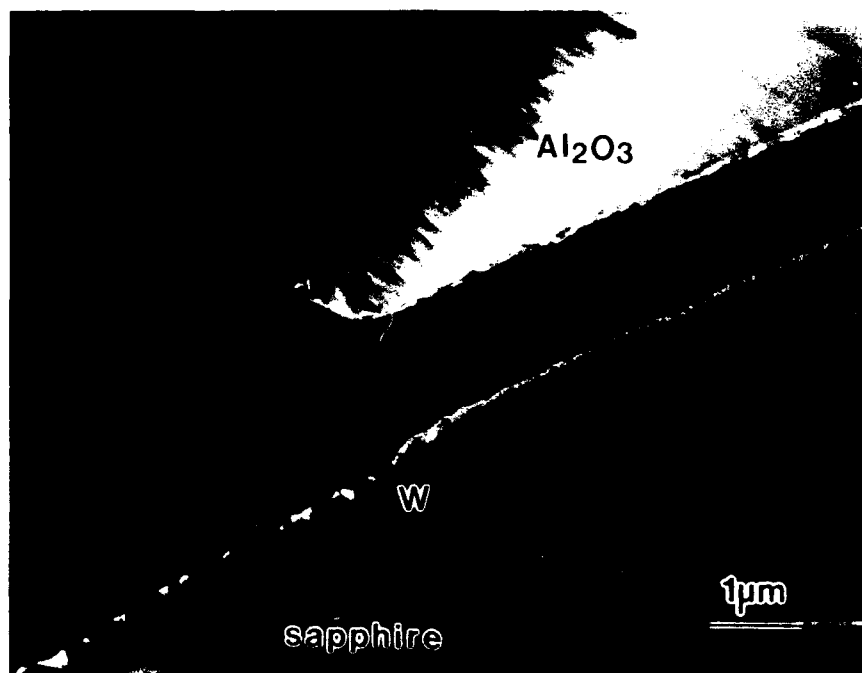
Figure 19. Low magnification dark field TEM micrograph of the sol-gel alumina and tungsten coatings on single crystal sapphire monofilament. Arbitrary diffraction conditions.
